**11<sup>th</sup> International Conference on Short and  
Medium Span Bridges  
Toronto, Ontario, Canada  
July 19 - 22, 2022**

## **POST-TENSIONING INVESTIGATION AND CORROSION MITIGATION IN VOIDED SLAB BRIDGES**

**Abstract:** Post-tensioned voided-slab concrete bridges have been used extensively since 1960s for continuous bridges spanning between 30-40m. They are an aesthetic alternative to I-girder and box-girder bridges because they are slender and have a smooth soffit. Their shallow depth and high torsional rigidity make them ideal for skewed and straight highway bridges with isolated supports and for interchanges where several curved roadways cross at different elevations. Many of these bridges have aged and some of them have even visible tendon corrosion such as concrete spalling and strand break due to improper grouting, voids and water/moisture ingress.

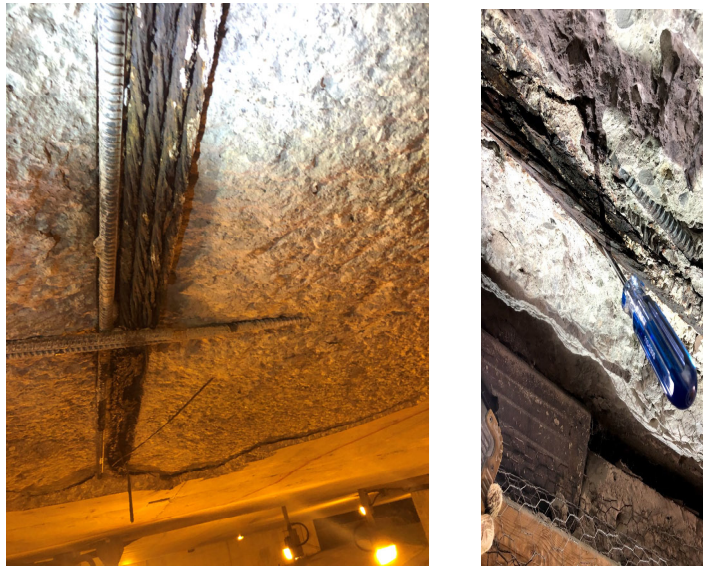
Steel is refined from iron ore (iron oxide) which is the natural form of iron. Great energy is used to convert iron ore into iron and steel, in the process heat energy in the blast furnace remove oxygen and leaves elemental iron. High-carbon steel wire rod is cold drawn into prestressing wires, and then 7 wires were twisted into one prestressing strands; more energy is stored in the strands in this process. Prestressing strands are more susceptible to corrosion than mild steel rebars (Figure 1) (Liao and Miyasato, 2018).

Figure 1: Prestressing Strands More Susceptible to Corrosion than Black Steel Regular Reinforcement - Strand Corrosion due to Poor Grout

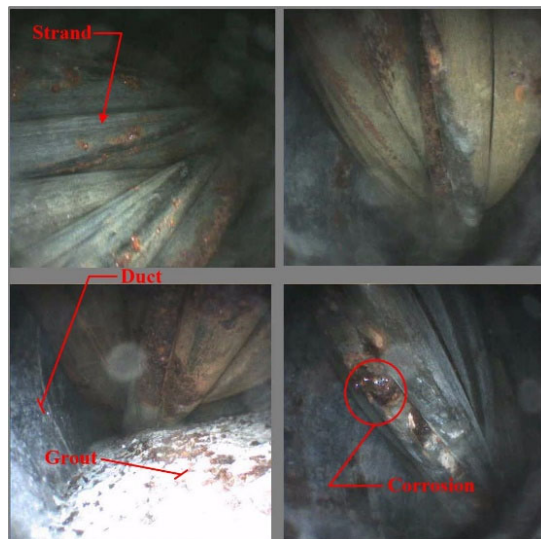
Figure 2: Strand Corrosion in Voided Ducts especially at Poor Grout Surface.

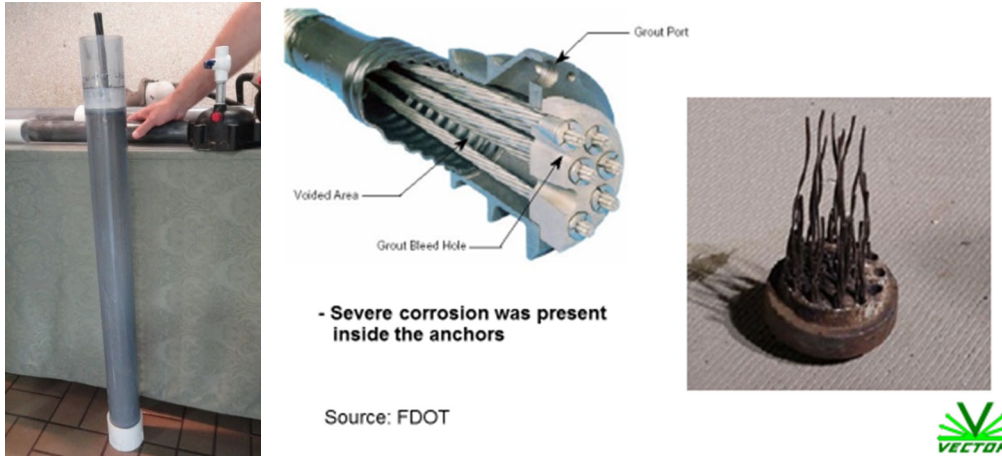
Figure 3: Duct Void Created At High Points Of Tendon Profile Such As Just Below Anchorage Or Negative Moment Area Due to Wicking Action Of The Bleeding Water Along the Interstitial Space Between Wires And Between Strands.

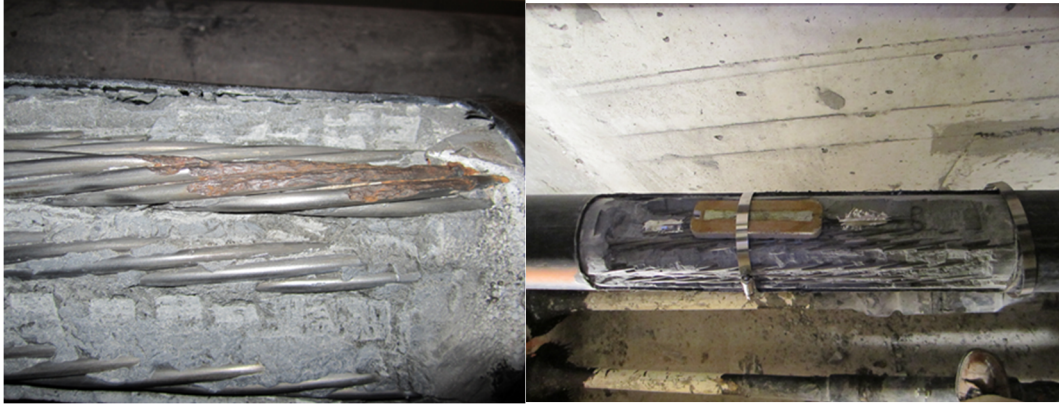
Figure 5: Galvanic Anode Installed to Mitigate Corrosion After Dissimilar Grout Accelerated Corrosion Discovered

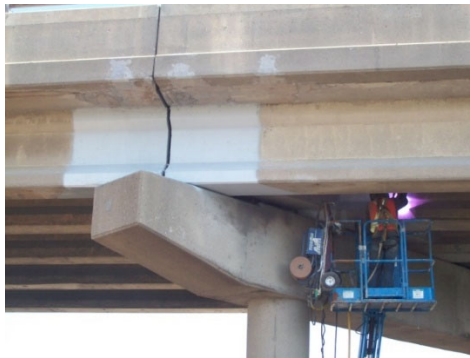
Figure 6: Galvanic Anode Installed to The Girder Ends to Mitigate Strand Corrosion

This method is practical and effective in mitigating steel corrosion in areas where concrete removal is not desirable, such as post-tensioned members and precast prestressed girders (Figure 6).

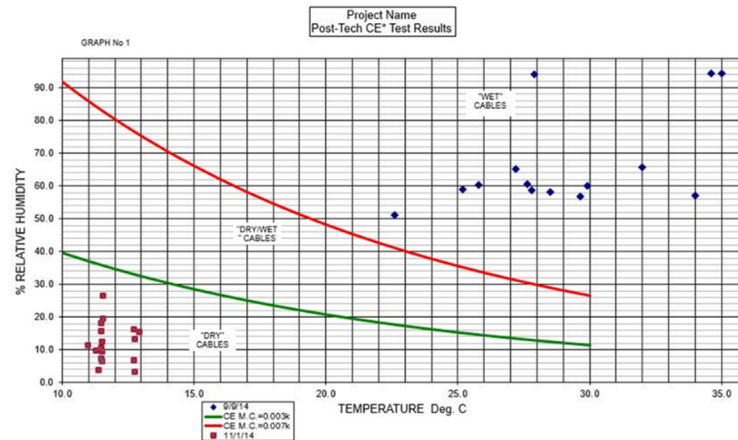
Figure 7: Water/Moisture From Wet Cables Purged and Corrosion Mitigated

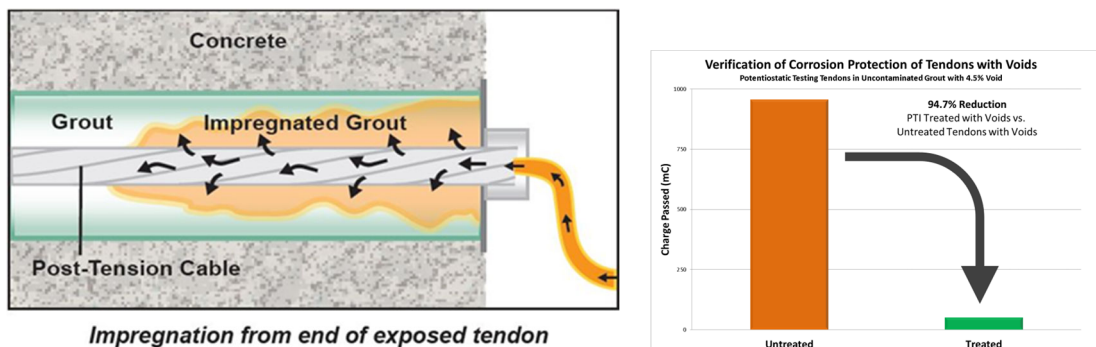
Figure 8: PT Tendons Impregnated To Increase Corrosion Resistance

The system utilizes the interstitial spaces between the wires of each strand in a multi-strand tendon to deliver (transfer) a unique corrosion inhibiting, impregnation material along the length of the cable (Figure 8). The impregnation material seeps between the wires of the strands to impregnate the surrounding grout or concrete. The impregnation material is designed to form a corrosion-resistant film on any exposed steel surfaces such as steel strands which are exposed in grout voids, and to make the grout more corrosion and moisture resistant (Whitmore, Lasa and Liao, 2015).

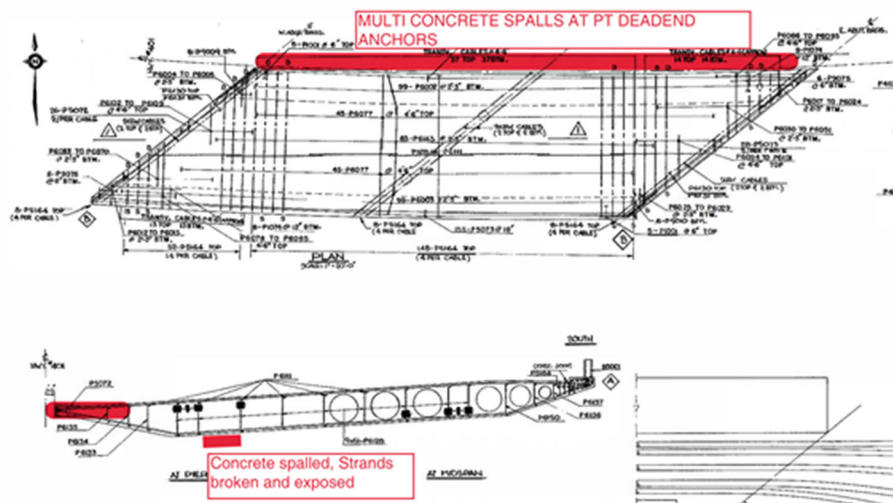
The bridge structure was built in early 1970s and are comprised of 2 spans. The bridge is post-tensioned voided slab bridge, 240' long 44' wide and sloped at 6% toward WB Express. The north side of the bridge is in a more corrosive environment due to water pooling and roadside splash from both EB and WB. The concrete near the north pier column has spalled and exposed one transverse tendon (Figure 9, Figure 10).

Figure 9: Dead End Anchor Corrosion, Strand Corrosion and Spalls at Lower Areas of the Soffit

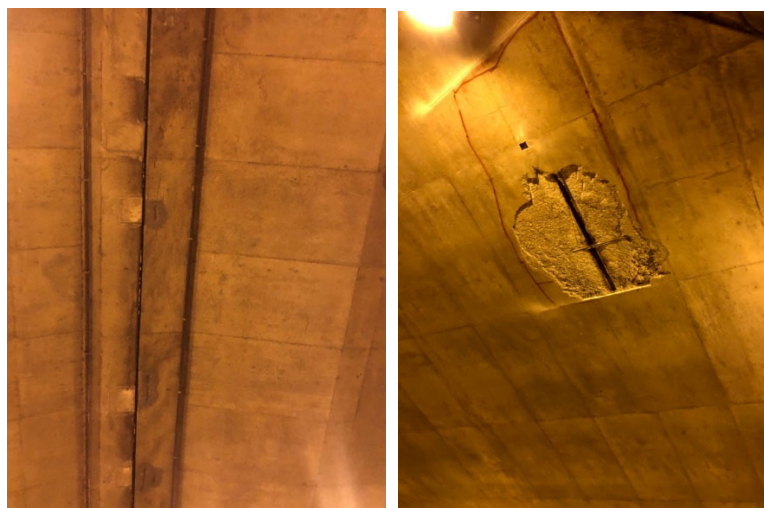
Figure 10: Dead End Anchor Corrosion, Strand Corrosion and Spalls at Lower Areas of the Bridge.

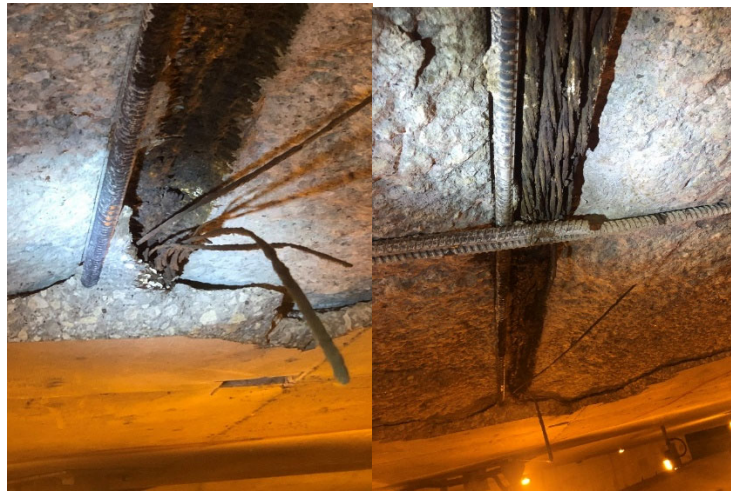
- Visual Inspection and Penetration test for the exposed tendons. All 4 strands in the transverse tendons are broken. The rebar below the tendon appeared in good condition, see Figure 11 and 12.

Figure 11: All 4 Strands Broken at Lower North Corner of the Soffit.

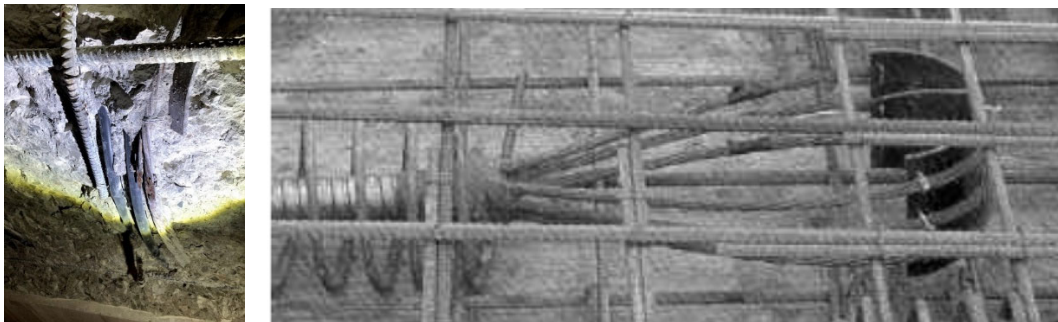
Figure 12: Looped Deadend Anchor Corrosion

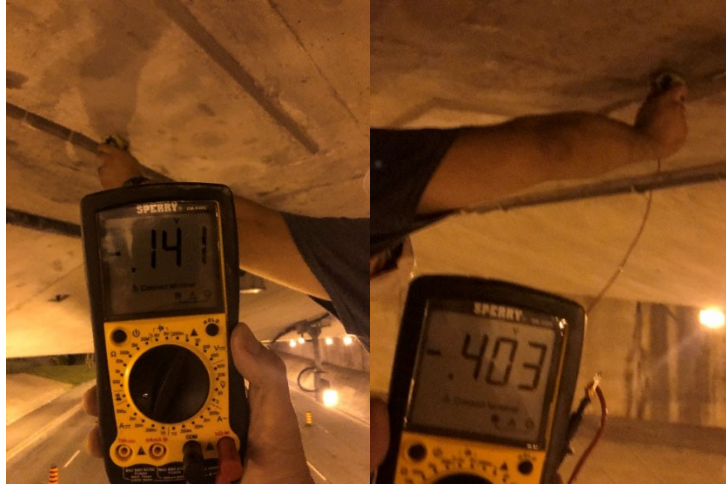
Using copper copper sulfate reference electrode, half-cell corrosion potentials in the repair areas ranged from -141 to -236mV, which was low compared to the threshold of -350mV. However the original concrete at the slab edge had the corrosion potentials ranging from -370mV to -403mV (Figure 13), which exceeded the threshold of -350mV, indicating more than 95% of probability of active corrosion. It was consistent with the high chloride content at the slab edge.

Figure 13: Corrosion Potentials Measured at patch and adjacent concrete. High corrosion potential in adjacent concrete and Lower in patch can form a macro cell to accelerate corrosion in adjacent concrete.

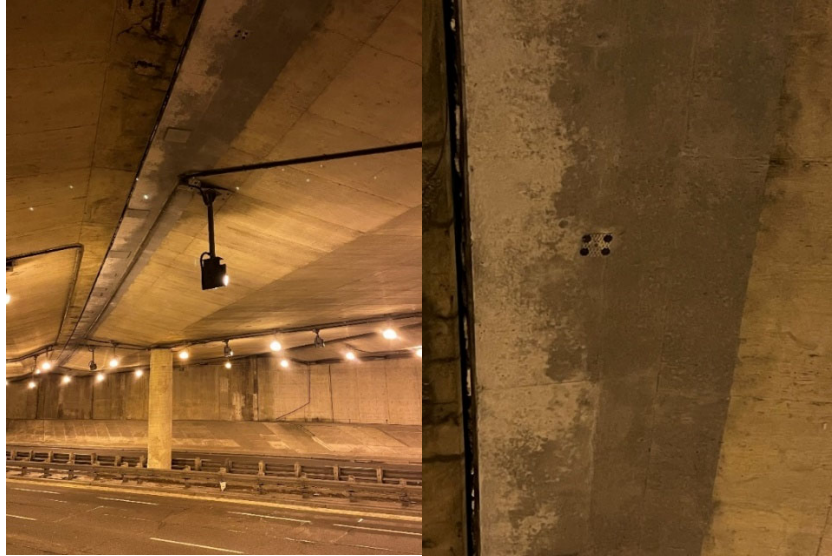
Figure 14: Activated Arc Sprayed Zinc anodes applied to the north soffit and connected to the steel

Corrosion mitigation by Activated Arc Sprayed Zinc anodes is applied to north slab edge where the area is low and corrosive, and where the corroding deadend anchors are located (Figure 14).

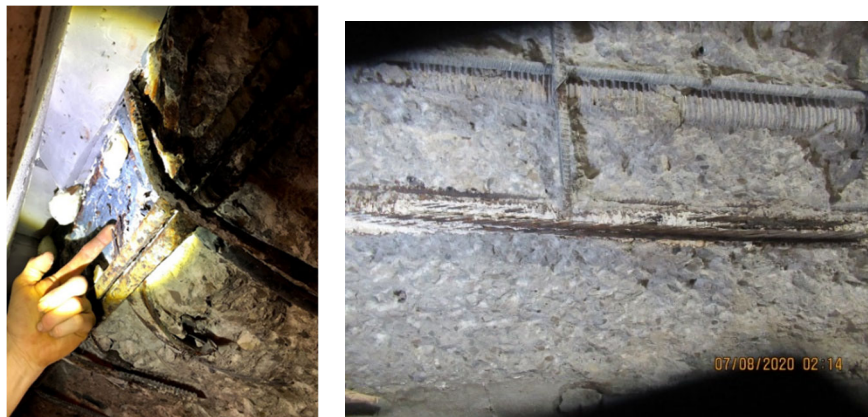
Similar investigation results were found in this Structure, and Similar corrosion protection strategies were employed to arrest the corrosion (Figure 15 &16). Distributed galvanic anodes were proposed for the patch repair to protect the tendons and the rebars, and PTI Impregnation was proposed for the transverse tendons as well.

Figure 15: Dead End Anchor Corrosion, Strand Corrosion and Spalls

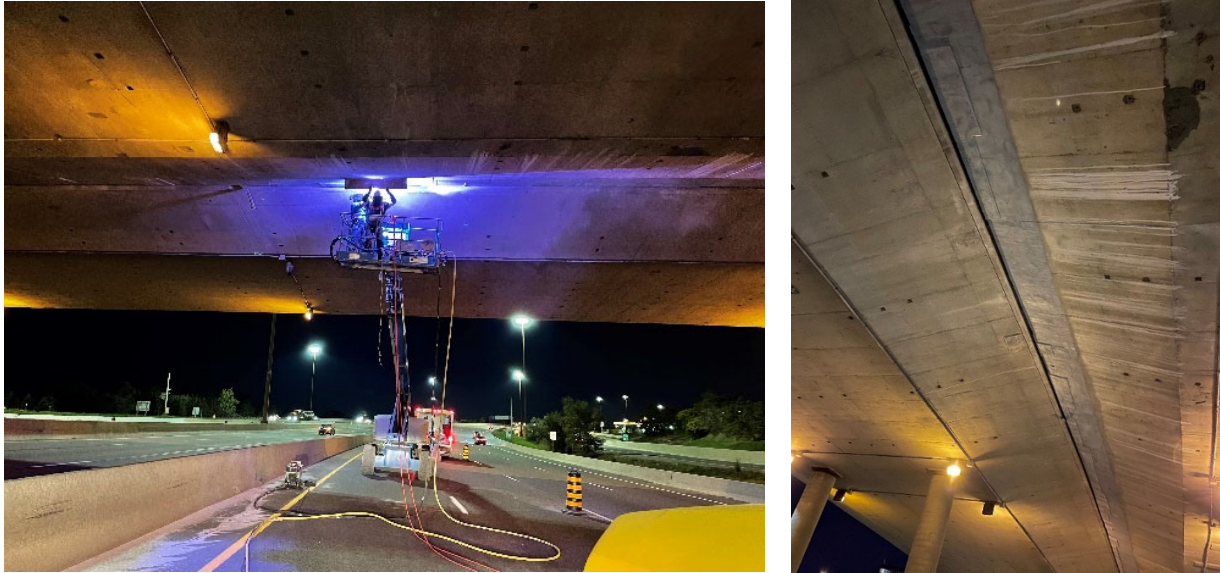
Figure 16: Activated Arc Sprayed Zinc anodes applied to the north soffit and connected to the steel
