**11<sup>th</sup> International Conference on Short and  
Medium Span Bridges  
Toronto, Ontario, Canada  
July 19 – 22, 2022**

## **POST-TENSIONING INVESTIGATION IN PRECAST SEGMENTAL BRIDGES**

This paper will describe various non-destructive testing and destructive testing methods to evaluate the condition of post-tensioning tendons and present some case studies including the Burnhamthorpe Road West Bridges over the Credit River, in the City of Mississauga.

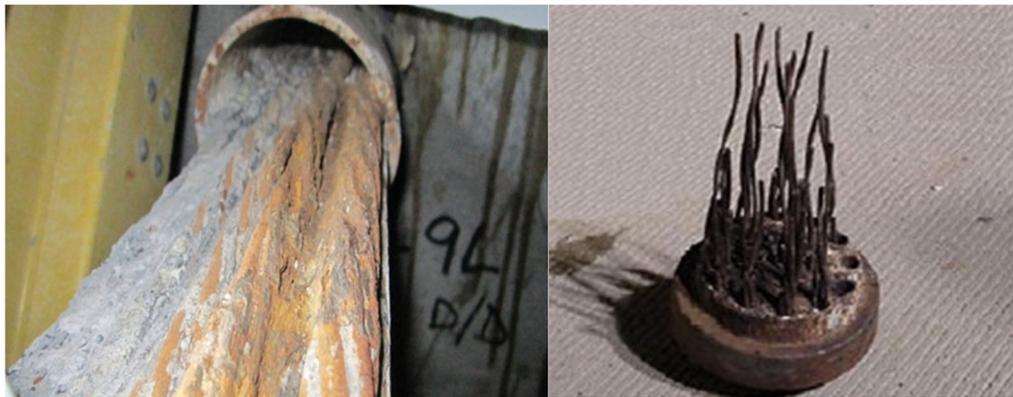
- Voids – Incomplete filling of the ducts with grout can result in water leakage into the voids prior to hardening of the grout. These voids are usually a result of grout bleed, where excess water in the grout floats to the top of the grout. This results in a pocket of water or a void, if the water later dissipates. Grout bleed was a common occurrence in the early application of PT structures with cement – water grouts and typically ranged between 3 and 5% of total grout volume. These voids often appear at the high point of draped PT strands (Figure 1).

Figure 1: Voiding of PT Grout at Anchorage

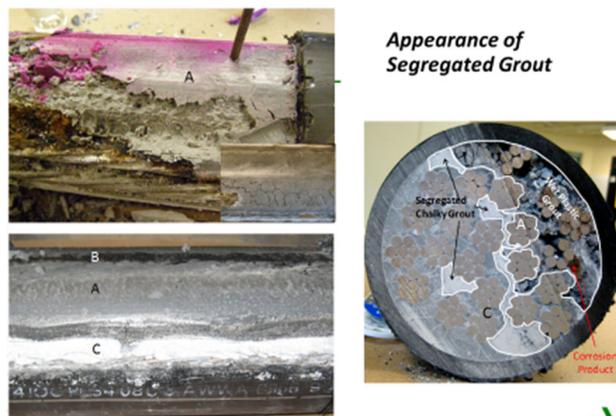
Figure 2: Segregation of PT Grout

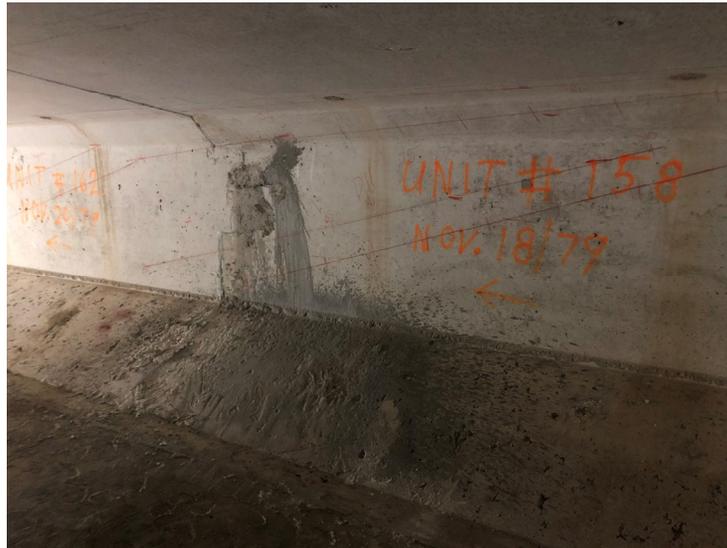
Figure 5: Tendon Locations Detected and Marked on the Wall

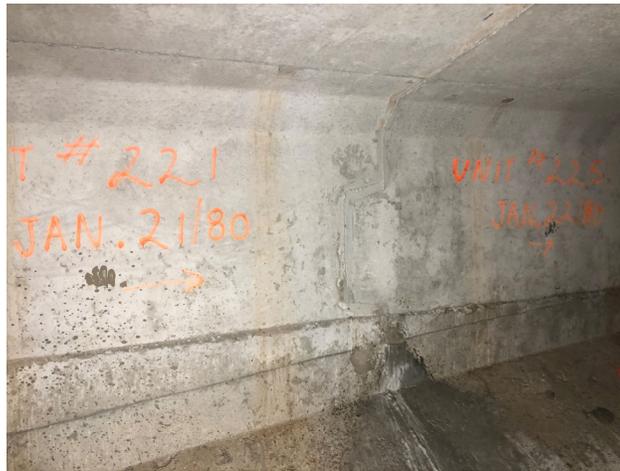
A walkthrough visual inspection inside the box girders was performed, no delaminations and spalling along the tendons were found at the time of inspection.

Figure 8: Shear Key

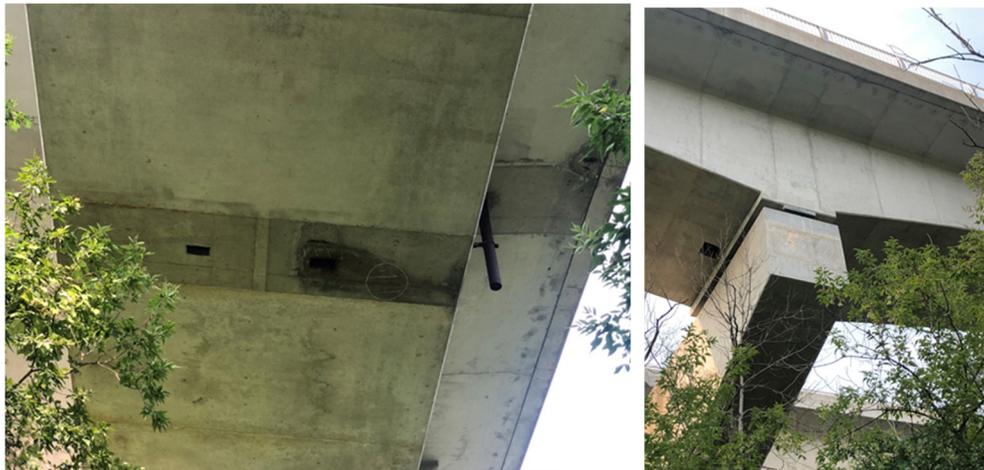
Exterior inspection was performed, spalls were found at the closure strips between the segments, and at the anchor pockets of the transverse tendons on the hammer head piers.

Figure 9: Exterior Inspection: Corrosion & Spalling at Closure Strip, Spalling at Transverse Anchor pocket

No delamination and spalling along the tendon inside the box girders was found. Exterior inspection was performed, spalls were found at the closure strips between the segments, and at the anchor pockets of the transverse tendons on the hammer head piers.

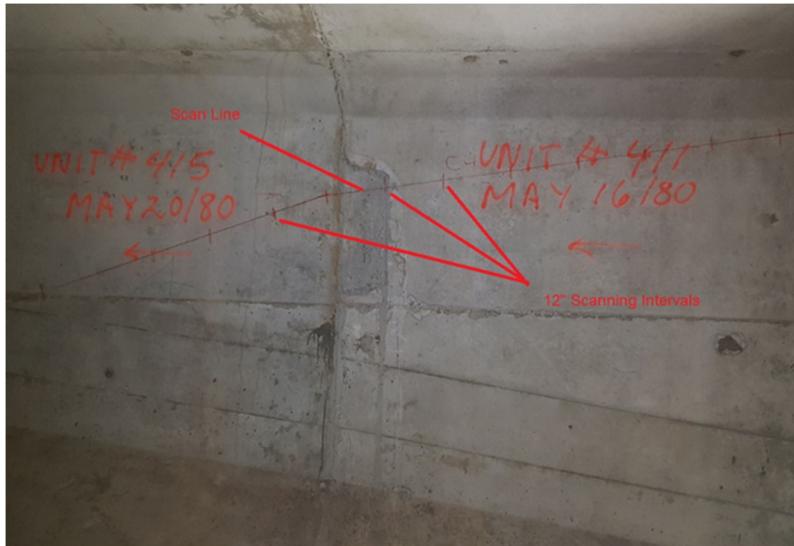
In total 12 cables throughout the two structures were scanned. All cables were scanned at 12" intervals starting at the end anchors. See Figure 10 below. The scanning length was restricted to lengths where the cable was within the concrete structure but not inline with adjacent cables.

Figure 10: Scan Line with 12" Intervals

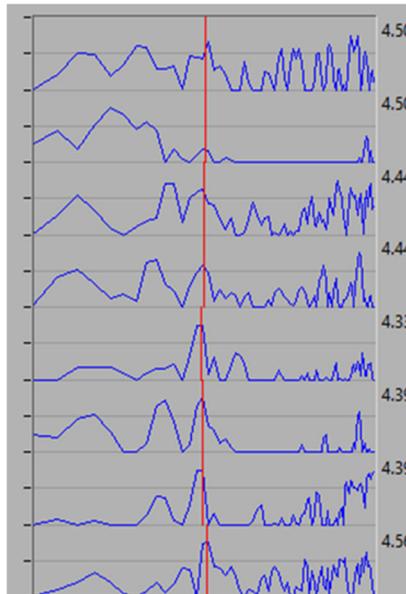
These frequencies are used to develop a sequence of images that collectively reviewed identify anomalous locations. See Figure 11 below for a sample of frequency reading. These readings were interpreted by a geophysicist prior to verification drilling. No lost, spurious or low frequencies were identified in any of the scan locations suggesting the absence of voids inside the tendon ducts.

Figure 11: Typical Sonic Impact-Echo Frequency Record
