**11th International Conference on Short and
Medium Span Bridges
Toronto, Ontario, Canada,
July 19 - 22, 2022**

GALVANIC CATHODIC PROTECTION FOR ACCELERATED BRIDGE CONSTRUCTION

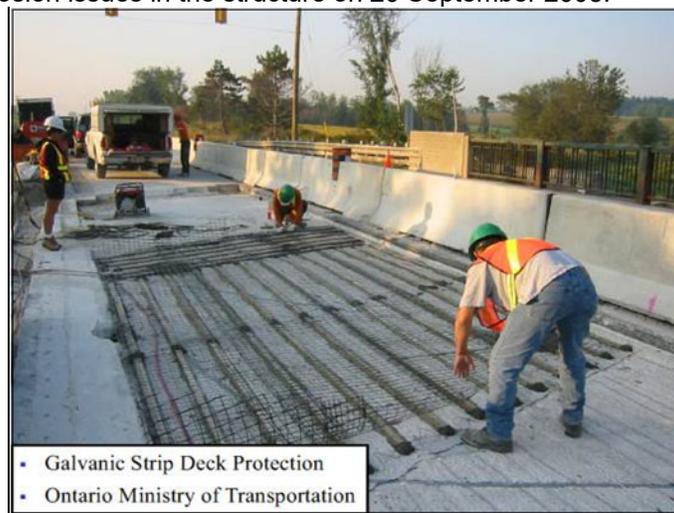
Figure 1: First Trial of DAS Anodes in Bridge Deck Overlay, Ontario, Canada, in 2003

In September 2003, DAS anodes were installed at the south end of the bridge to monitor a deck area of about 26 square metres. This consisted of precast strips placed on approximately 300 mm (1ft) centers. Each DAS anode consisted of two zinc rods encased in a proprietary cementitious backfill containing lithium hydroxide. The DAS anodes measured 12mm by 50mm and were 2440mm in length. A carbon fibre mesh was used to prevent or reduce shrinkage cracks in the concrete overlay and to provide a better bonding surface. Plastic anchors were used to fasten the carbon fibre mesh in place until the concrete overlay was placed. Prior to the installation of the anodes, the bridge was scarified.

Four multiple-element probes (MEP) were installed at two locations. At each location, a MEP was placed next to the top and bottom mat of reinforcement. The MEP consisted of a manganese dioxide reference cell, a stainless steel and a mild steel probe, and a connection to the reinforcement. This arrangement allows for the long-term evaluation of reinforced concrete structures and can be used to evaluate the effectiveness of a cathodic protection system. The distributed anode system along with the respective instrumentation was terminated in a junction box. Each junction box contained a system on/off switch and a 0.001 ohm precision resistor. This arrangement allowed the anode current to be measured and the current density generated by the anodes to be evaluated (with respect to concrete surface area). The MEP may be used to confirm the current density value. The manganese dioxide reference cell from each probe was used to determine the polarization received by the reinforcement. The four values were then averaged to determine a polarization value for each system. It should be noted that all the embedded instrumentation was backfilled with concrete containing the typical amount of chloride found in the deck (at the reinforcement level). Except for winter months when the bridge deck froze and current and corrosion potential readings were not reliable, more than sufficient current was being supplied by each of the anodes to meet the 100 mV criteria generally accepted as indicative of effective cathodic protection (Table 1).

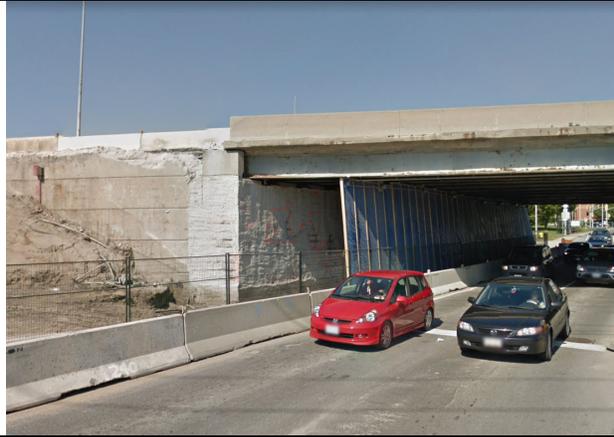
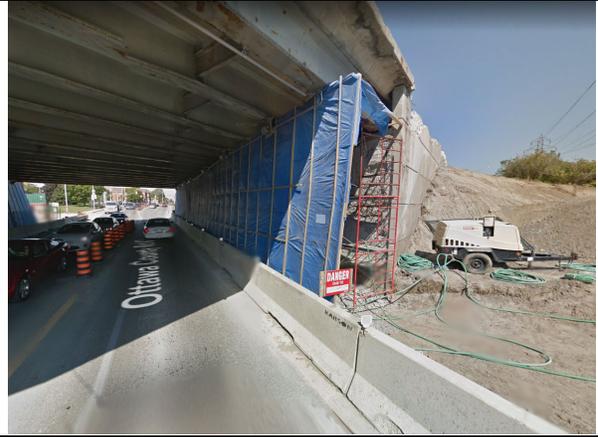
(a) West abutment south side

(b) East abutment south side

Figure 3 Rehabilitation of abutments with DAS galvanic cathodic protection

To preserve and extend the service life of the existing abutments, it was decided to remove 25 mm of concrete from the abutment face and all delaminated concrete. A sacrificial distribution anode system was designed and installed on the concrete abutment stem wall. The continuous anode strip system was spaced at 500 mm vertically throughout the abutment and wingwall surfaces. The system was designed to provide a minimum of 20 years of service life assuming a maximum annualized average anode current density of 10.0 mA/m²; an anode efficiency factor of 0.9 and an anode utilization factor of 0.8.

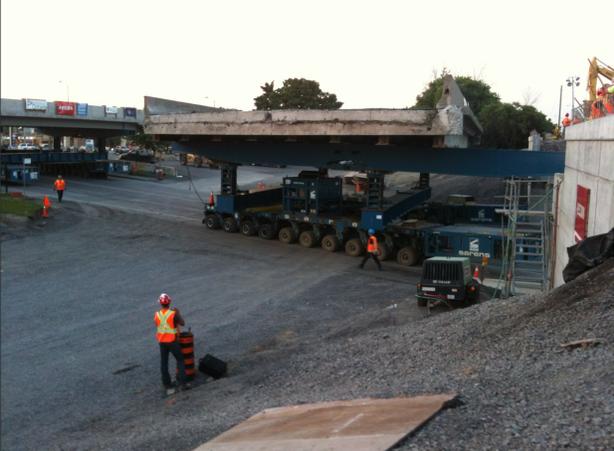
(a) Removing existing bridge decks

(b) Installing new bridge decks

Figure 4 Transporting existing and new prefabricated t bridge deck

5. Rapid lift operation completed on July 6, 2013, in 17 hours. This involved completely closing a 3 kilometres portion of the Highway, removing the asphalt and granular back fill behind the ballast wall, raising and moving the existing superstructures to the staging area, transporting/placing/levelling the new superstructure in position, backfilling/paving/placing of temporary traffic barriers and opening the bridge to regular traffic.

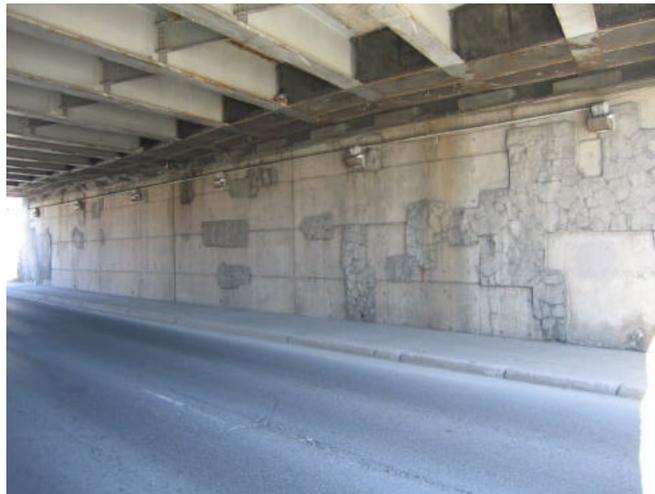
Figure 5 Elevation of the East Abutment, looking northeast

- Spalls and delaminated concrete covered approximately 15% (26.4m²) and 10% (16.4m²) of the exposed faces of the east and west abutments respectively
- Chloride content at the steel level of the west and east abutments was 0.111% and 0.297% respectively, which are well above the threshold of 0.025% by mass of concrete inducing corrosion
- Over 93% (159.7m²) and 97% (164.5m²) of the east and west abutments respectively exhibited corrosion potentials more negative than the threshold value of -0.35V required to induce corrosion in the reinforcing steel.
- Shotcrete repairs from a 1983 bridge rehabilitation extend over 25.8% and 20.6% of the east and west abutment respectively exhibit delaminations, map cracking (Figure 5).

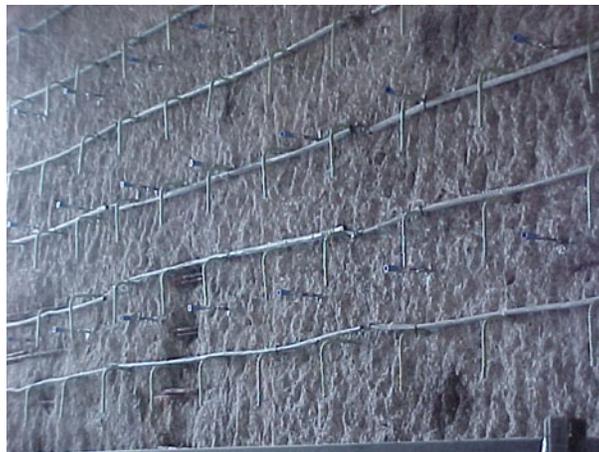
Figure 7 DAS galvanic cathodic protection installation

The anode had 0.89kg/m and were spaced at 500mm on centers, the zinc mass/m² is 1.78kg. Using Faraday's law and the average current density of 2.86mA/m² and basing the zinc mass alone, the zinc can last 60 years.
