**11th International Conference on Short and
Medium Span Bridges
Toronto, Ontario, Canada
July 19 - 22, 2022**

SUBSTRUCTURE REHABILITATION USING GALVANIC ENCASEMENT OF THE FREDERICK G. GARDINER EXPRESSWAY

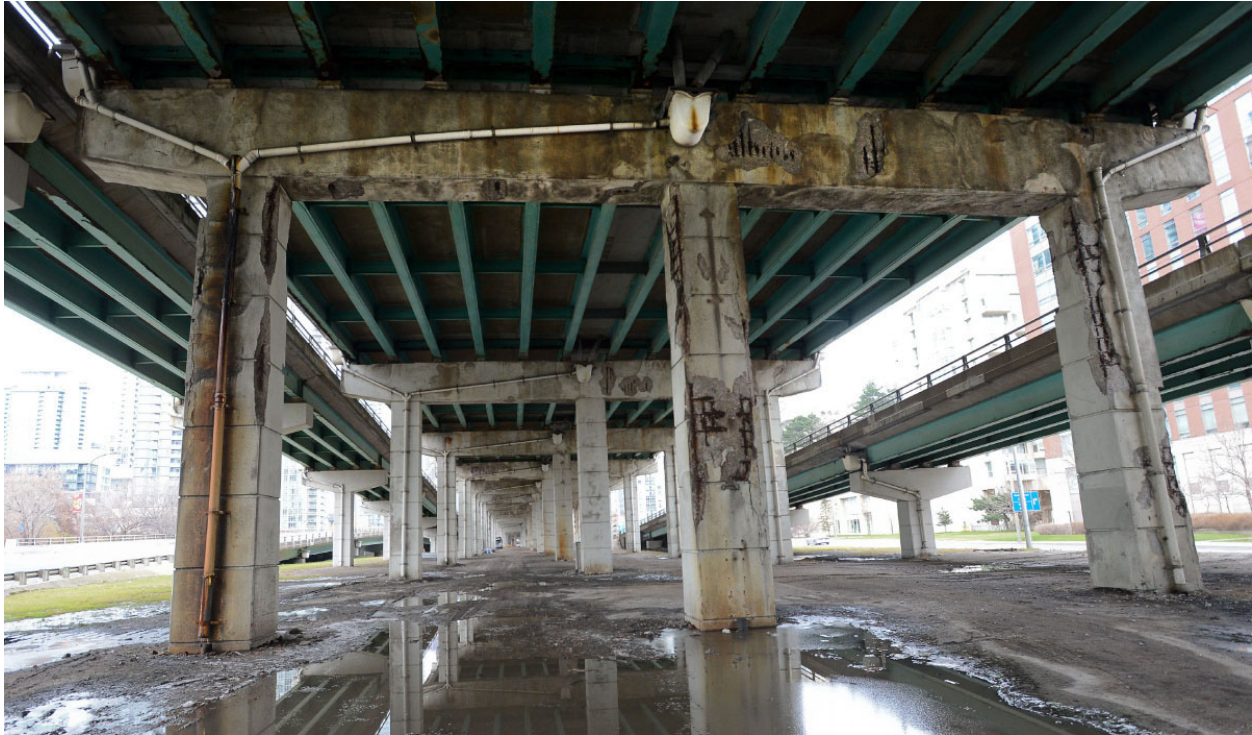
The primary cause of the aforementioned deterioration of the Expressway substructure is chloride induced corrosion which has been left unchecked and has led to deterioration of the substructure. Originally designed as a series of simply supported spans, expansion joints at each substructure component deteriorated resulting in the leakage of chloride contaminated drainage onto the piers.

Figure 1: Pier Concrete Corrosion due to Leaking Expansion Joints and Chloride Contamination

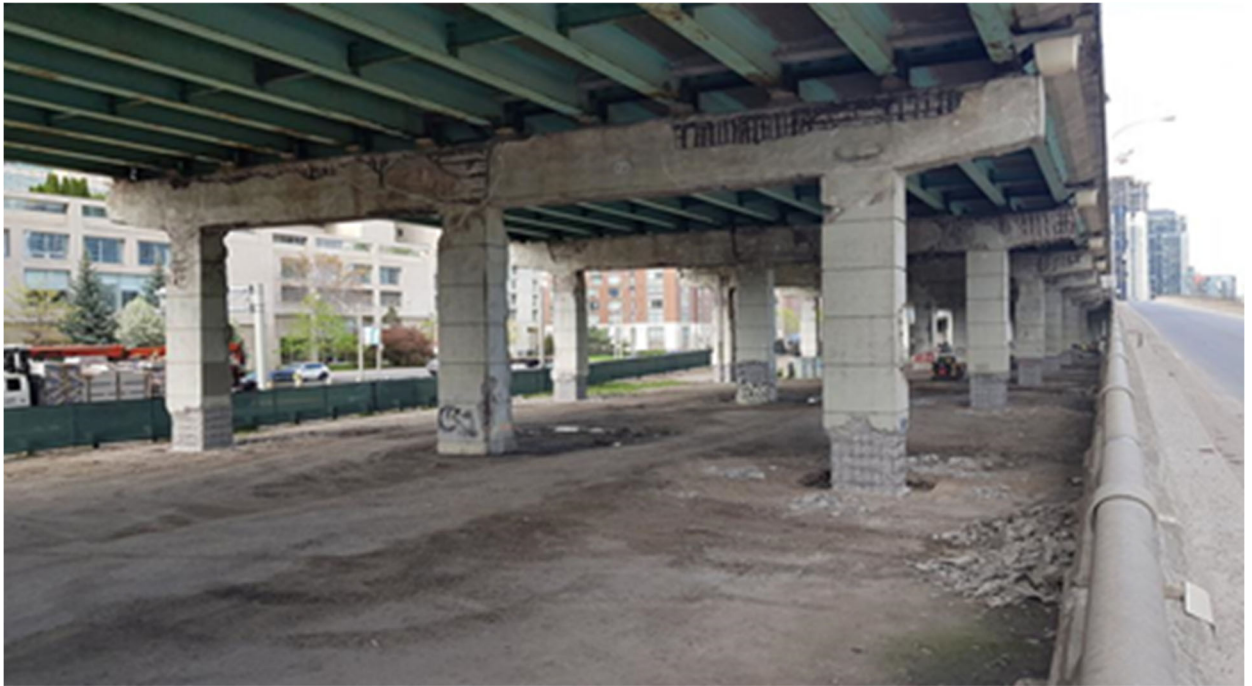
Figure 2: Pier Corrosion Due to Chloride from Leaking Joints and Roadside Splash

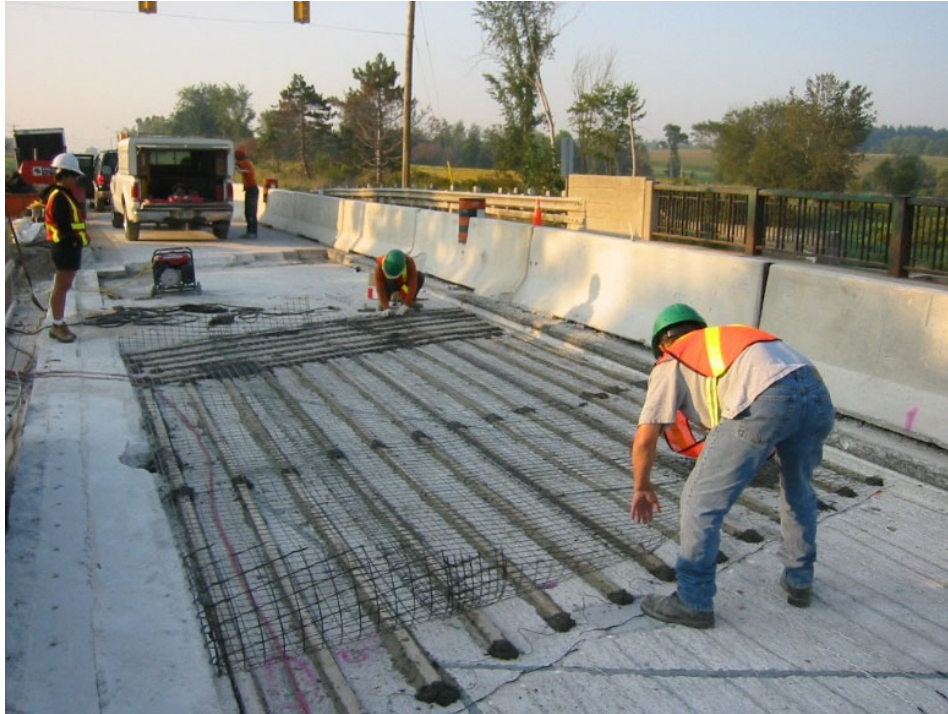
Galvanic anode systems do not require specialized knowledge for commissioning, and they can significantly minimize the need for future monitoring and maintenance. The Ontario Ministry of Transportation conducted the first application of distributed galvanic anodes in a bridge deck overlay in September 2003. The installation was completed on the North Otter Creek Bridge.

Figure 3: First installation of distributed galvanic anodes on a bridge deck prior to bridge deck overlay, Ontario, Canada, 2003

The distributed galvanic anodes in this project have been performing well. The 15-year monitoring data has shown the polarization of 100mV has been achieved except during the winter period or when the depolarization period is not sufficiently long (Lai, Langendean & Liao 2018). Many transportation agencies including MTO have used this type of anode in many different components, including abutment refacing, concrete deck overlays, and concrete jackets for columns, piers and marine piles.

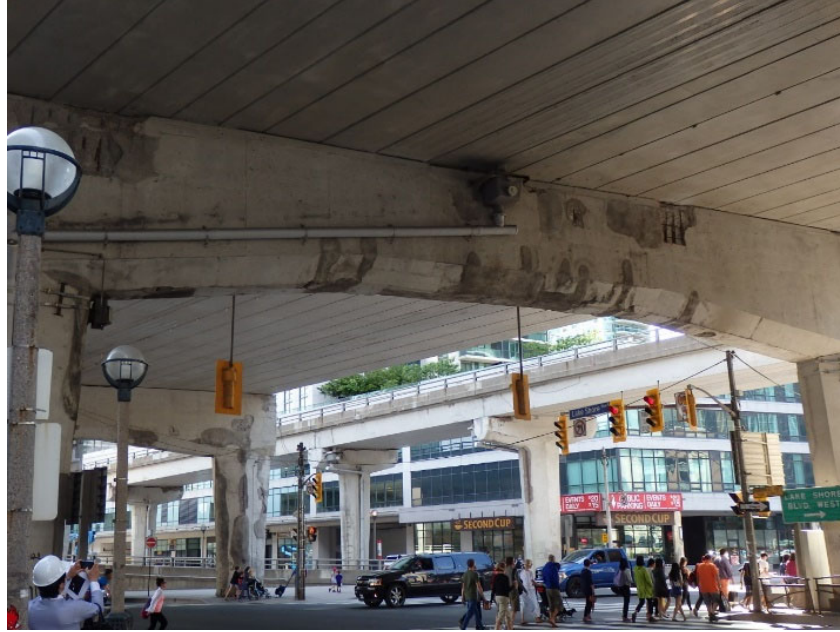
Over 60 years of exposure to de-icing salts has resulted in reinforcing steel bar corrosion and significant damage to the substructure of the Gardiner Expressway. The City of Toronto has invested significant time and money in concrete repairs in the substructure. In the past, repairs were predominantly removal and concrete refacing/jacketing of the piers without addressing the corrosion of the reinforcing steel.

Figure 4: Corrosion Damage of Columns and Pier Caps with Patch-Accelerated Corrosion Evident

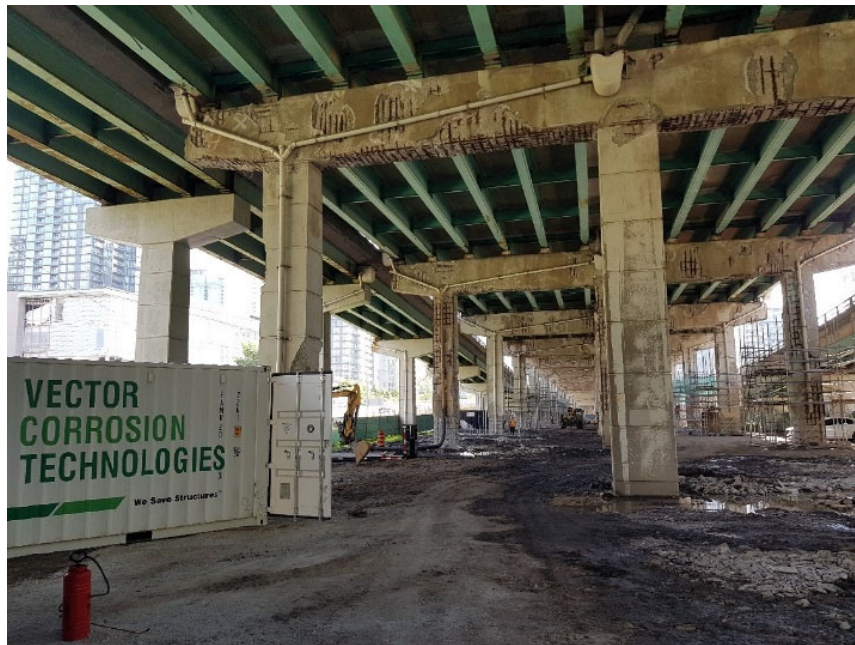
Figure 5: Corrosion Damage of Columns and Pier Caps with Patch-Accelerated Corrosion Evident

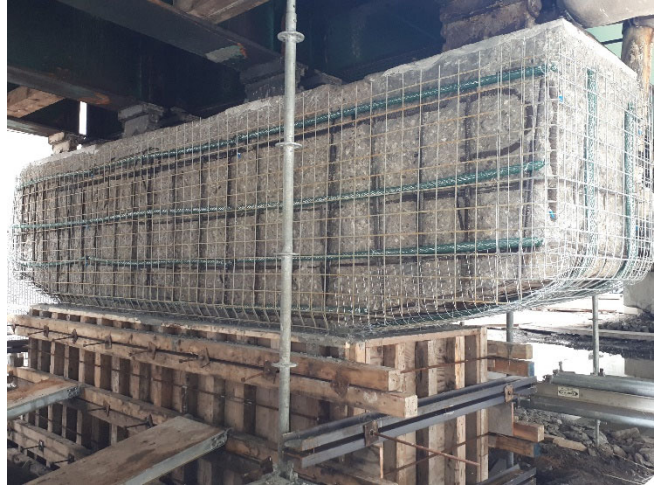
Figure 8: Galvanic Encasement Details

Over 320 m³ of concrete removal and 400 m³ of refacing concrete were used to rehabilitate 2700 m² of substructure. Average depth of removal was approximately 100 mm and the total thickness of the refacing/jacket was 125 mm. The total Contract cost was approximately \$6,800,000.00. Due to the advanced state of concrete deterioration “staged” repairs as well as some shoring of the steel beams at the bearing locations were required.

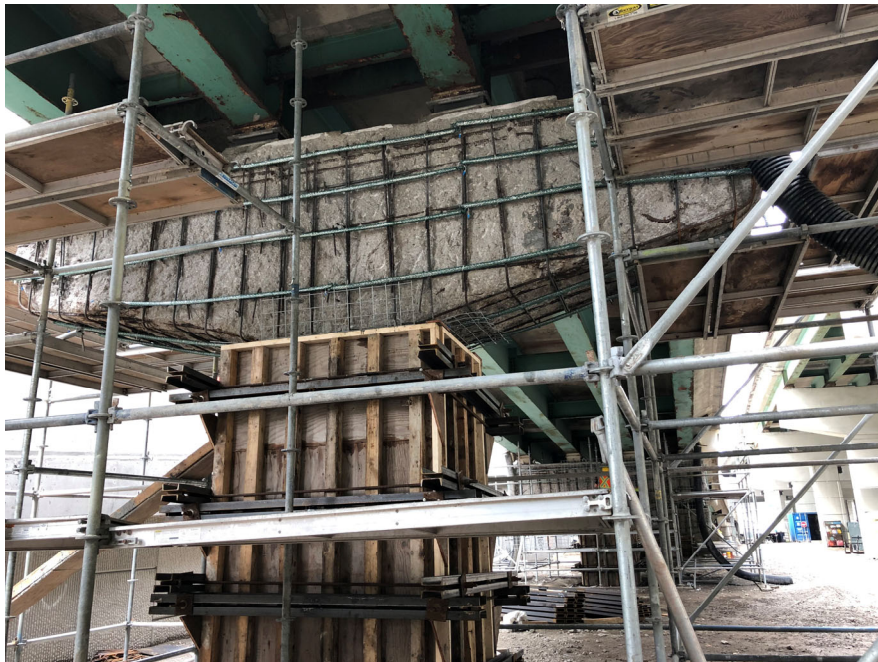
Figure 9: Galvanic Encasement for Hammer Head Pier (Green “bars” are the Distributed Galvanic Anodes)

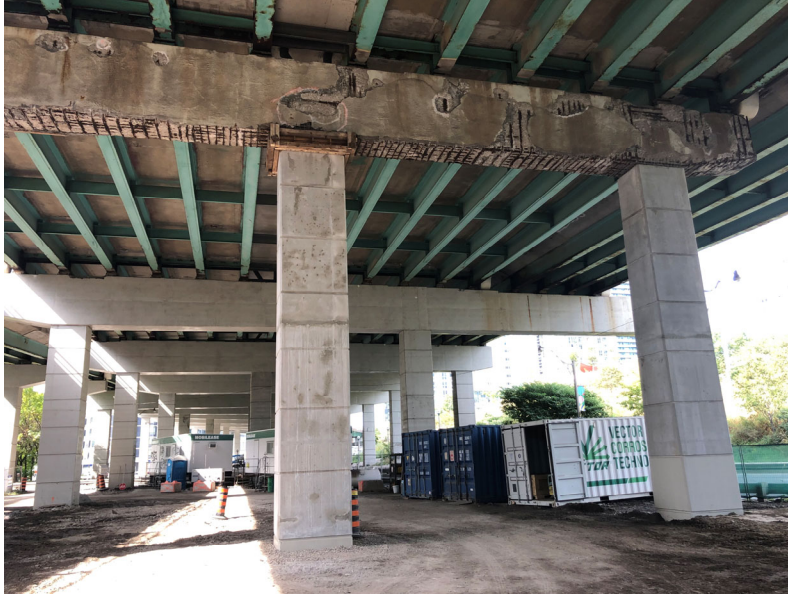
Figure 10: Completed Piers in the Background with a Partially Completed Pier in the Foreground
