**11<sup>th</sup> International Conference on Short and  
Medium Span Bridges  
Toronto, Ontario, Canada  
July 19 - 22, 2022**

## **GEOSPRAY CASE STUDIES FOR CORRUGATED STEEL PIPE CULVERT REHABILITATION**

## **8 CASE STUDY 1 HIGHWAY 406 DICK'S CREEK CULVERTS, ST CATHARINES, ONTARIO**

## 9 CASE STUDY 2 HIGHWAY 403 NEAR EGLINTON AVE, MISSISSAUGA, ONTARIO

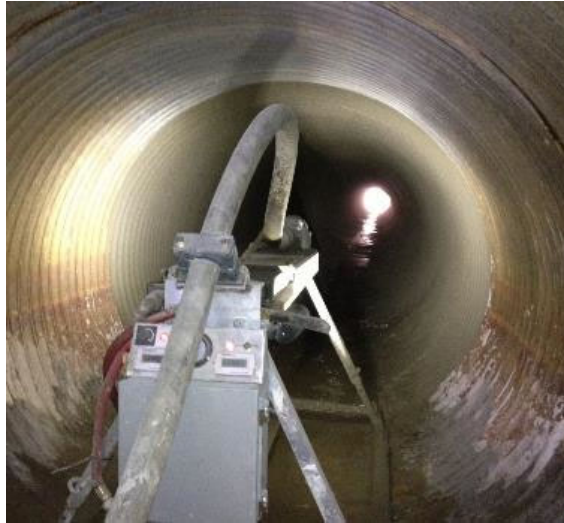
Picture 4: Lining machine applying.

The lining installation can be conducted by two different methods: Centrifugal spin casting and hand spray. Each single pass applies 20-25 mm of geopolymer thickness to the host pipe. The geopolymer mortar is mixed on the surface with a water to material ratio of 0.19 – 0.20 and then either spray applied via spin casting machine or manually hand applied on pipe sections of larger diameter.

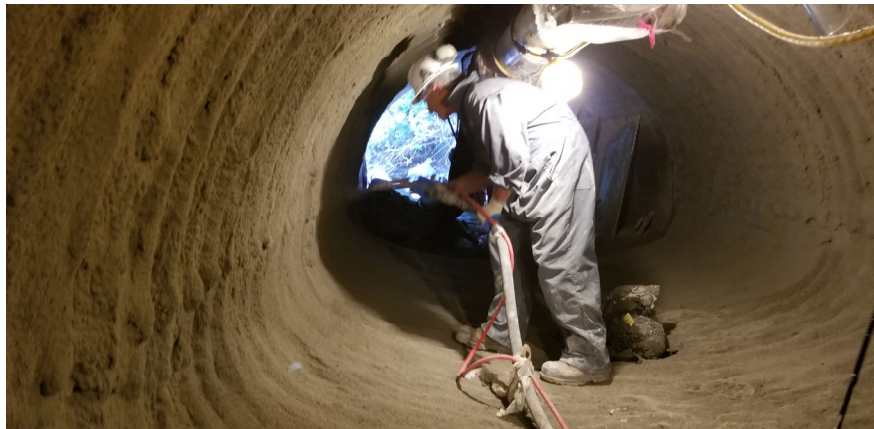
Picture 5: Hand Spray.

The hand spray liner installation methodology is used for larger diameter CSP, the ends of the CSP culverts, irregular pipes, and culverts with narrow entries where the slopes of some sections exceeding 15%. The hand spray application typically uses 20-25% more material as it is not possible to follow the contours of the corrugations accurately by hand and therefore it fills in the corrugations on the pipe and t creating a smoother hydraulic finish.

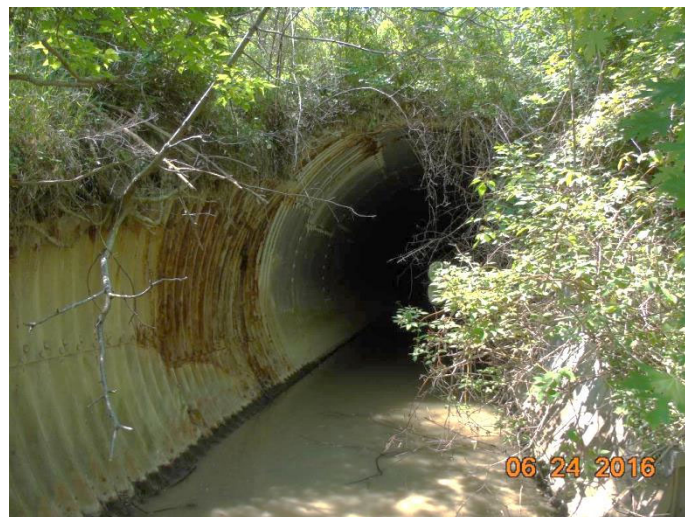
Dick's Creek culvert consists of two (2) CSP culverts with each cell having a diameter of approximately 4m, length of 94m and fill of 5.6m over the culverts. Prior to the rehabilitation, the culvert's condition in general was in a fair to good condition. However, the first 10m of the inlets and outlets demonstrated severe corrosion due to de-icing salt from the roadside splash. Although the deterioration was at the ends, a feasible rehabilitation strategy was required to prolong the service life of the structures and to prevent a local failure of the culvert ends and the embankments. With the high fill over the culverts and the embankments having a different slope at each end, the replacement of the culverts ends through the open cut excavation was costly and not desirable. Other alternatives such as installation of CSP liner and concrete liners also imposed construction challenges, introduced traffic impacts on Highway 406 and impacted the hydraulic capacity. After assessment and evaluation of various alternatives, GeoSpray liner was selected as the feasible rehabilitation strategy. The thickness from the preliminary design is 50mm.

Figure 7: Pipe Corrosion at Entrance

The construction scope included 4 x 10m end sections of the two CSP culverts to be sprayed to a minimum of 50mm thickness. Each end took one week to complete including pipe prep, cleaning and water ingress control, application, and QA/QC testing.

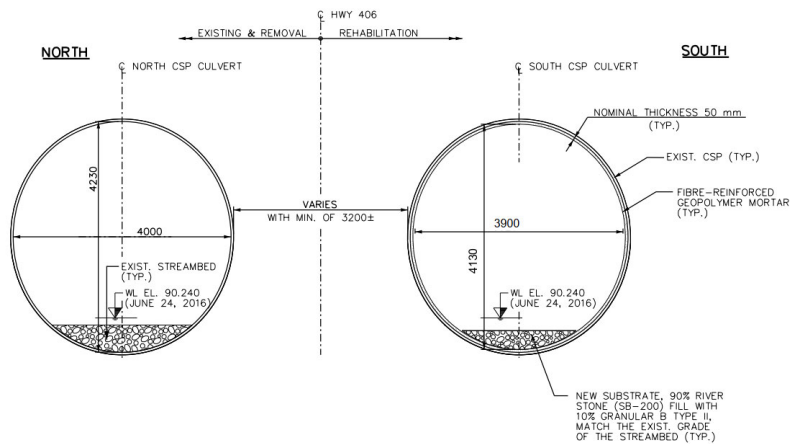
Figure 8: Rehabilitation Cross Section

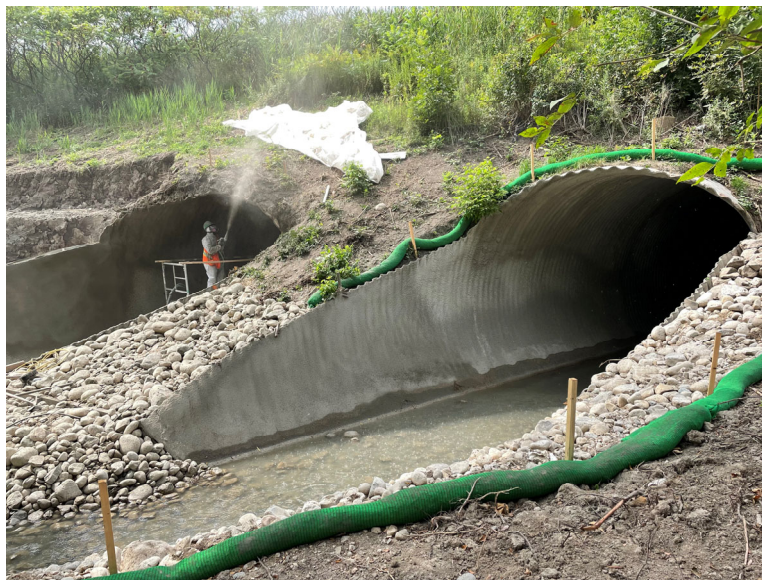
Figure 9: Hand Spray

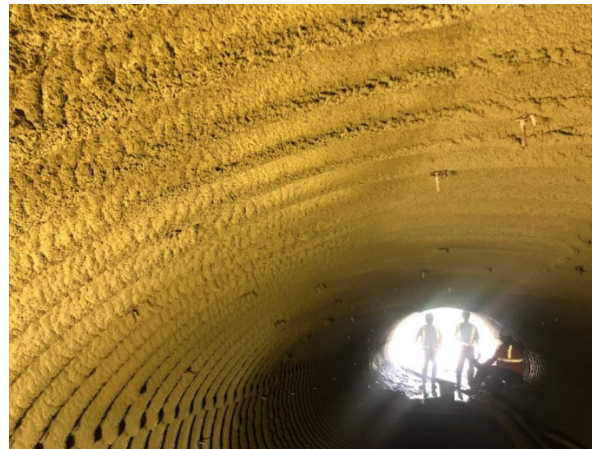
Figure 10: Pipe after first pass

The construction scope included spraying 10m section of the pipe to a minimum of 70mm thickness, which took 1 week to complete with 3 days of spraying and testing. The laydown area is immediately adjacent to the pipe mouth which affecting the wetland in the downstream of the pipe, and the highway 403 traffic was not impacted. The water bypass was set up by dam and gravity bypass pipes through work area with secondary pumping to capture any overflow.

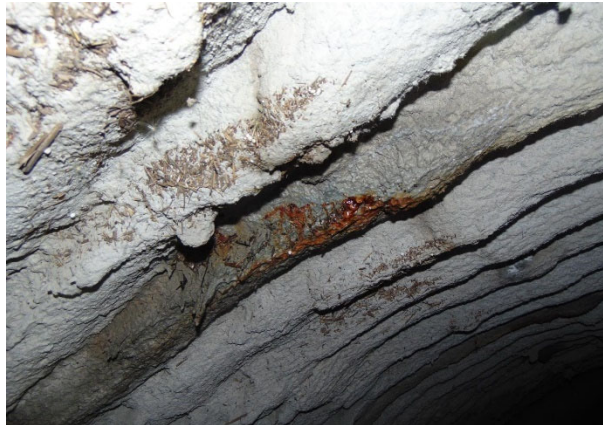
The culvert's condition after a year of Geo-spray liner application at the local section of the outlet revealed that repaired section overall is in a good condition. The Geo-spray lined section demonstrated no signs of deformation or progression of the deformation from the host pipe. However light corrosion in few areas and local leakage through the Geo-Spray lined section as shown in Figure 11 was identified in areas where previously severe corrosion was noted in the host pipe prior to the rehabilitation. The leakage and local light corrosion may attribute to the extent of surface preparation prior to the lining, challenges involved during the construction with the use of hand-spray application in a small CSP, and possibly minor leaks. Although pressure washing was completed prior to the Geo-spray lining application, further local wire brushing at areas with severe corrosion in conjunction with introduction of wall lining material on

the culvert's surface particularly at splice location maybe necessary prior to Geo-spray application to prevent leakage and corrosion deposits penetrating from the host pipes through the cracks on the Geo-sprayed lined section to the surface. In addition, the CSP ceiling was too low for hand spray application. The distance from the nose to CSP ceiling was too close where the pressurized material caused a great impact onto the adjacent just-sprayed material, where it caused it to deform and hence created more porosity and rough surface.

Figure 11: Culvert's Condition a Year After Liner Installation

- Rough surface of 403/Eglinton. The roughness does not affect the strength, as consolidated thicknesses are exceeded. The crown of CSP (3.3m x 1.8) is low for handspray, the distance from nose to CSP surface is too close, the pressurized material cause a great impact onto the adjacent just-sprayed material, and cause it to deform hence the rough surface. If smooth appearance is preferred, hand-trowel immediately after the spray can smooth the surface.
