**VECTOR  
CORROSION  
TECHNOLOGIES**

# Post-Tech<sup>®</sup> PTI Impregnation System

Corrosion Protection System for  
Bonded Post-Tension Tendons

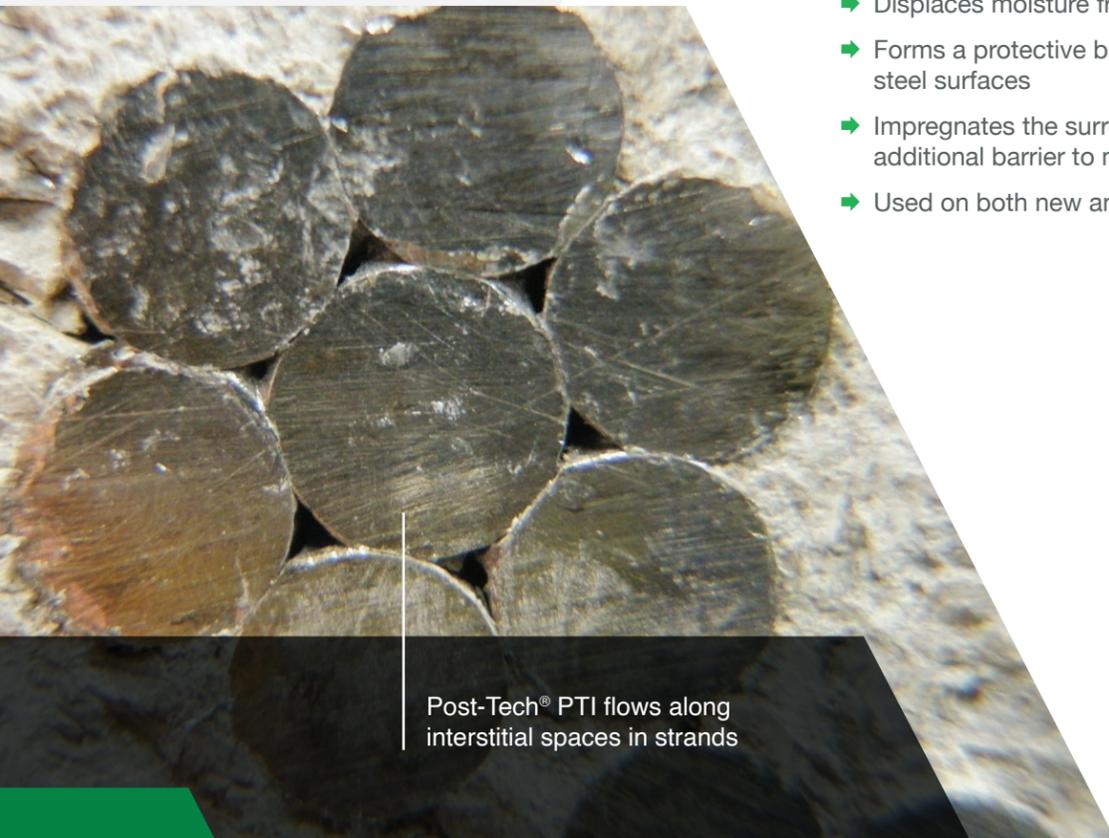
Post-Tech® PTI flows along interstitial spaces in strands

The Post-Tech® PTI system uses the naturally occurring interstitial spaces in high strength steel strands to deliver a formulated low viscosity dual action hydrocarbon silicon polymer resin.

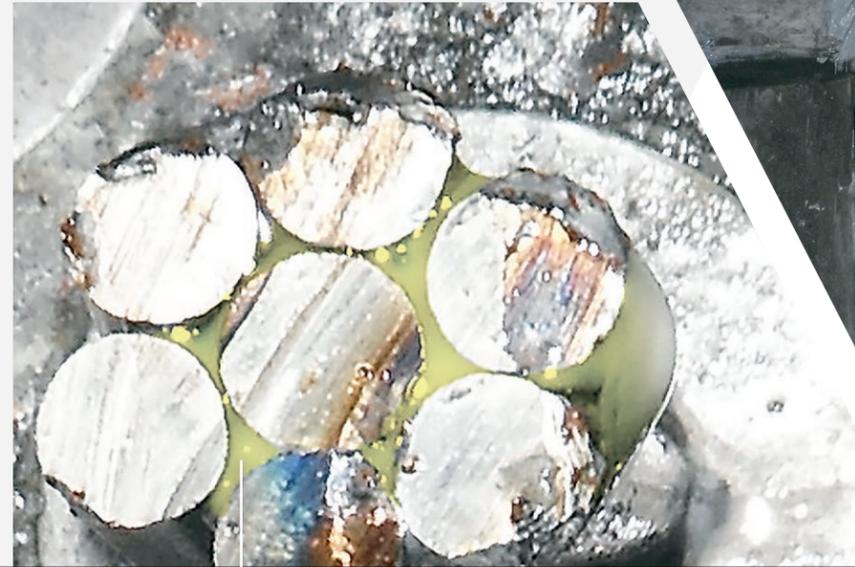
Example of impregnation being completed from the end of the tendon and the Post-Tech® PTI Impregnation material (highlighted in yellow) exiting the opposite end of strands 250 ft (75m) away.

The Post-Tech® PTI impregnation process can be completed from the end anchorage or from intermediate locations along the length of the tendon. Experience has shown the Post-Tech® PTI impregnation material can flow through the interstitial spaces along the length of a tendon at least 250 ft (75m) from a single entry point.

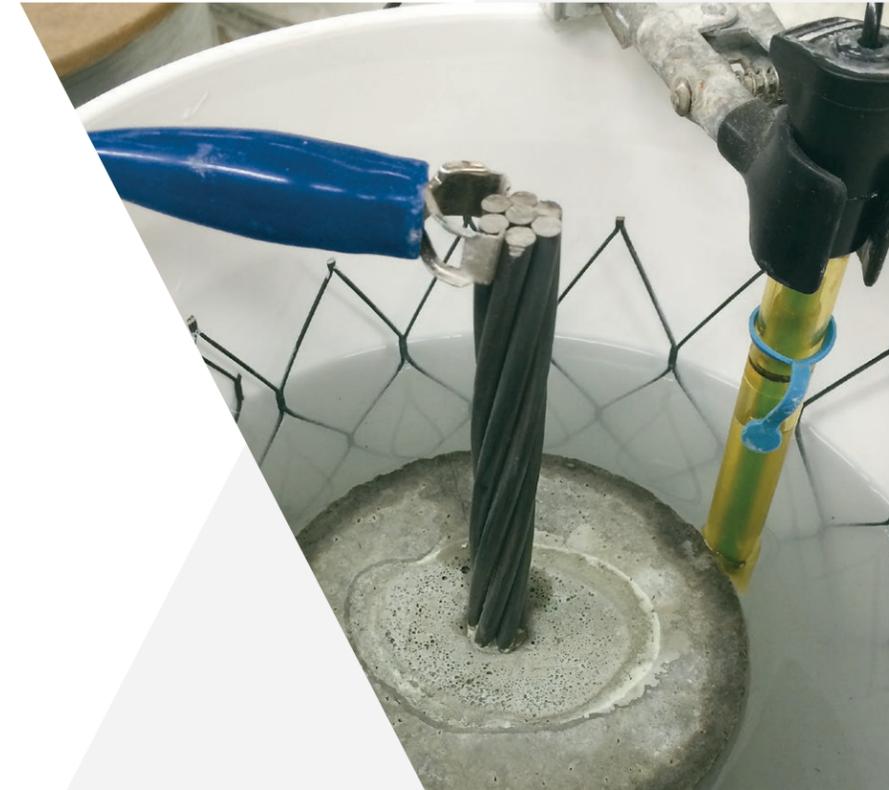
Post-tension Strands in Chloride-Contaminated Grout (2% Cl)

Post-Tech® PTI treated and untreated "lollipop" samples were subjected to a one hour potentiostatic corrosion test. The test automatically adjusts the applied current to maintain a constant steel potential of +200 mV versus a silver-silver chloride reference cell. In this test, resistance to corrosion is measured by the reduction in current passed. The Post-Tech® PTI treated samples passed significantly less current than the untreated controls.

Laboratory testing was also conducted to verify the performance of the Post-Tech® PTI Impregnation System on post-tension strands in chloride contaminated and chloride-free grout.
