**11<sup>th</sup> International Conference on Short and  
Medium Span Bridges  
Toronto, Ontario, Canada  
July 19 - 22, 2022**

## **POST-TENSIONING INVESTIGATION AND CORROSION MITIGATION IN VOIDED SLAB BRIDGES**

**Abstract:** Post-tensioned voided-slab concrete bridges have been used extensively since 1960s for continuous bridges spanning between 30-40m. They are an aesthetic alternative to I-girder and box-girder bridges because they are slender and have a smooth soffit. Their shallow depth and high torsional rigidity make them ideal for skewed and straight highway bridges with isolated supports and for interchanges where several curved roadways cross at different elevations. Many of these bridges have aged and some of them have even visible tendon corrosion such as concrete spalling and strand break due to improper grouting, voids and water/moisture ingress.

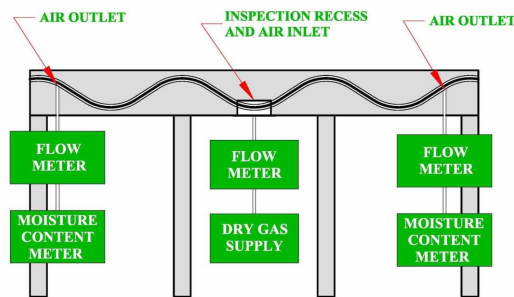
Figure 4: PT Corrosion Potential Evaluation by Testing Water/Moisture in Tendon Ducts

Probability of Corrosion	Moisture Content	Wet or Dry
Low	<0.003kg/kg	dry
Moderate	0.003 to 0.007 kg/kg	wet/dry
High	>0.007kg/kg	wet
