**11<sup>th</sup> International Conference on Short and  
Medium Span Bridges  
Toronto, Ontario, Canada  
July 19 – 22, 2022**

## **POST-TENSIONING INVESTIGATION IN PRECAST SEGMENTAL BRIDGES**

This paper will describe various non-destructive testing and destructive testing methods to evaluate the condition of post-tensioning tendons and present some case studies including the Burnhamthorpe Road West Bridges over the Credit River, in the City of Mississauga.

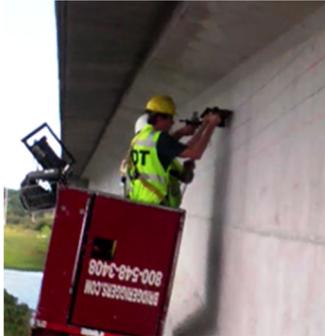
<p><b>NDT Ultrasonic/ Sonic Impact Echo Void Detection</b></p> <p>Ultrasonic/Sonic Impact echo is a non-destructive test that uses a projectile impact to create a compressional wave that propagates through the concrete thickness and the energy input is reflected back through the concrete from the back surface of the web/flange. This energy is trapped between the two surfaces and resonates at a frequency that is a function of the compressional wave velocity and concrete thickness. When anomalies are along the wave path such as soft grout or air voids (typical velocities – soft grout 4,000 feet/sec; air 1,000 feet/sec; concrete 14,000 feet/sec) it results in a longer travel path because the sonic ray path is diffracted around the anomaly.</p> <p style="text-align: center;">             Fully Grouted Duct                      Soft Grout or Voided Duc              Resonant Frequency = 8500Hz          Resonant Frequency =7,000Hz         </p>

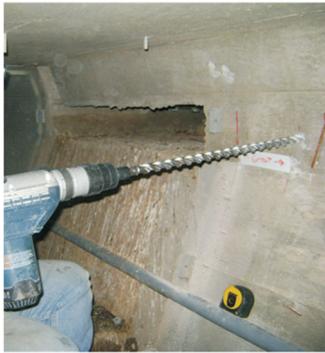
<p><b>Small Opening for Further Investigation</b></p> <p>An auto shutoff drill will be used to drill holes at the selected duct locations, the drill will automatically shut off when contacting metal, which avoids damaging the tendons. Small openings of 3/4 inch in diameter are created to verify the NDT ultrasonic/sonic impact echo results. When voids are found, a borescope inspection device is inserted to visually inspect the voids and strands. The drilled holes are also the inlets and outlets for the air testing.</p>

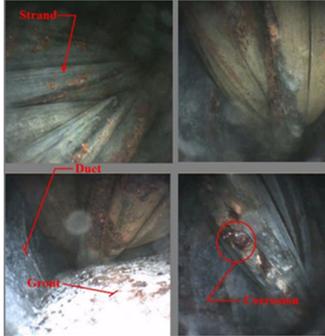
<p><b>Borescope Inspection</b></p> <p>The borescope provides the unique ability to visually inspect extremely small and difficult to access areas. It is capable of capturing video and still images along with recording audio from the inspector. The borescope has an overall length of 3 meters, diameter of 4 mm, and a 360° articulating head. The 3 meter cable length is made of stainless steel braid providing the necessary durability to the system for difficult and harsh environments. The cable is also able to penetrate into various liquids without harm to the device.</p>

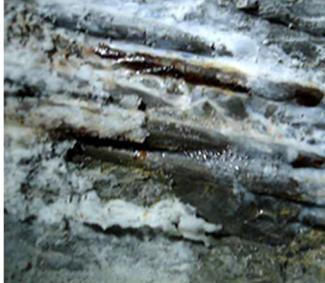
<p><b>Water/Moisture or Air test</b></p> <p>Air test can be performed to verify the air communications of the tendon along its length, which identifies the possibility of moisture/water migration along the tendon and determines the feasibility of some corrosion mitigation techniques along the tendon length. Air tests may also provide indication of water presence inside the tendon sheath.</p>

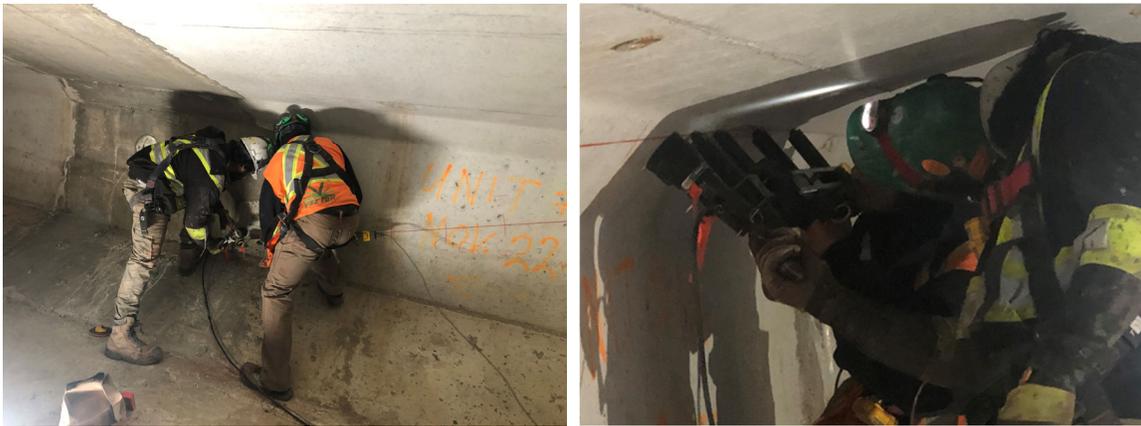
Figure 7: Sonic/ultrasonic Measurements

- Fully grouted duct: Thickness frequency in the range of 4.1 to 5 KHz with no spurious resonant frequencies
- Fully grouted duct with brittle / fractured / weak grout, possible thin (<1/4 inch) voids or honey combed deck concrete: Thickness frequencies in the range of 3.5 to 4.0 KHz with spurious resonant frequencies
- Duct suspected of having soft grout or a void : No Full thickness frequency or a thickness frequency of 2.8 to 3.5 kHz spurious frequency.
