Vector™
Galvanode® DAS
Project History

Manitoba Infrastructure and Transportation
Hwy. 59 and Hwy. 100 Grade Separation, Girder End Protection

Structure: Highway 59 and Highway 100 Grade Separation

Client: Manitoba Infrastructure and Transportation

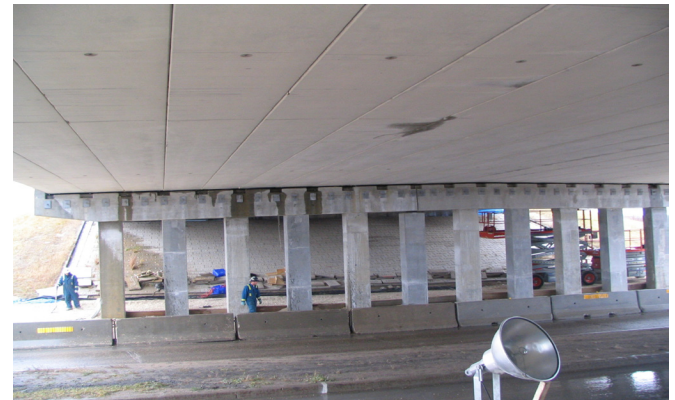
Pier caps jacketed with embedded Galvanode DAS anodes for corrosion control of chloride contaminated concrete

The use of Galvanode DAS anodes was selected to provide long-term corrosion control to the girder ends and the pier caps where the highest level of chloride contamination was to be found. The pier cap was overbuilt in phase 1 with additional reinforcing added to increase capacity of the structure. Galvanode DAS anodes were installed in the jacket to provide active protection to the embedded steel in the parent concrete. The girder ends were a greater challenge and were addressed in phase 2 of the project. The girders were raised so that the bearings could be replaced. While raised, concrete was removed from the underside of the girder ends and DAS anodes were installed to protect the lower portion of the girder end and grouted in place. The girders were lowered back on to their bearing pads.

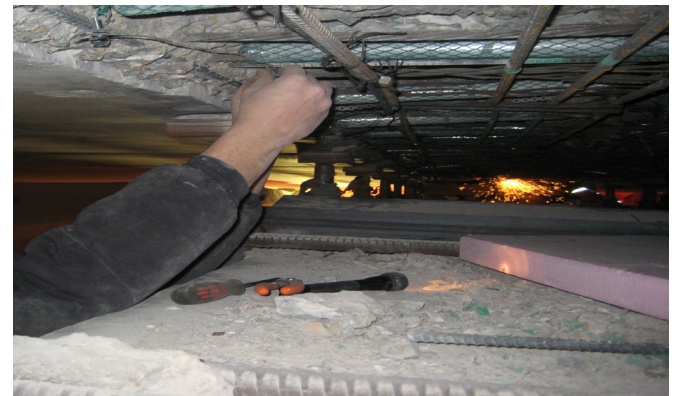
Galvanode DAS anodes installed within bearing area of box girders for corrosion mitigation of embedded steel

required. Prior to the installation of the overlay and expansion joints the vertical face of the box girder ends was removed to a depth of 150 mm. Galvanode DAS anodes were installed in the void and were grouted back in place.
