**Project History**

**Parking Garage Rehabilitation  
 Milwaukee, Wisconsin**

**Structure:** North West Mutual Parking Garage

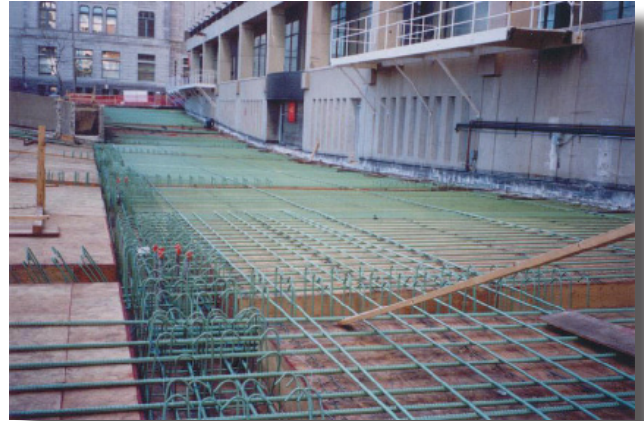
Galvashield installed at interface of new and existing concrete

To meet the project requirements, the consultant specified the use of epoxy-coated rebar, silica-fume concrete and a traffic bearing waterproofing membrane. Additionally, Galvashield XP anodes were tied to the existing black rebar that extended into the columns and perimeter walls to provide corrosion protection to the adjacent chloride-contaminated concrete.
