Project History

Canaveral Port Authority Cape Canaveral, Florida

- Structure:** North Cargo Pier Repairs
- Client:** Canaveral Port Authority
- Date:** April, 2005 - December, 2006
- Contractor:** Vortex Marine Construction
Vector Corrosion Technologies
- Products:** Galvanode® Jackets Galvashield® XP
Galvanode ASZ+ Galvashield CC
Galvanode DAS

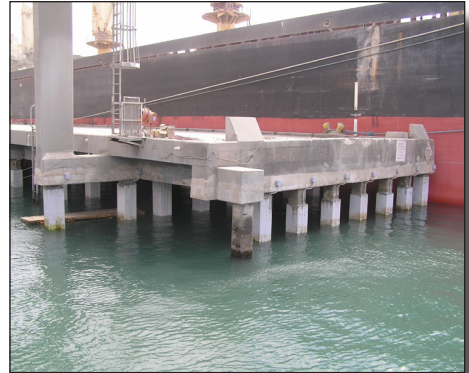
Galvanode Jacket for Pile Protection

The pile protection consisted of Galvanode Jackets to protect 668 piles. The Galvanic Jackets consisted of 1.6 lb./ft² zinc mesh anodes, 48 lb. bulk zinc anodes and a 1/8 in. thick stay in place FRP form. The length of piles protected ranged from 6 to 30 feet.

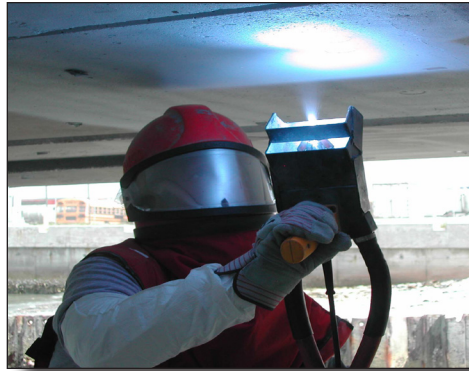
Galvanode ASZ+ on Precast Deck Units

The prestressed concrete deck units were protected using Galvanode ASZ+ (Activated Arc Spray Zinc), applied to the deck soffit by Vector Corrosion Technologies. Approximately 57,500 ft² of prestressed concrete deck units were protected. The prestressed deck units that had existing corrosion damage were to be strengthened using bonded carbon fiber sheets after the repairs were completed. Galvanic protection was provided to these deck units using a combination of Galvashield XP anodes around the perimeter of the repairs and Galvashield CC135 anodes installed on holes drilled on a grid pattern through the remaining sound but chloride contaminated area.

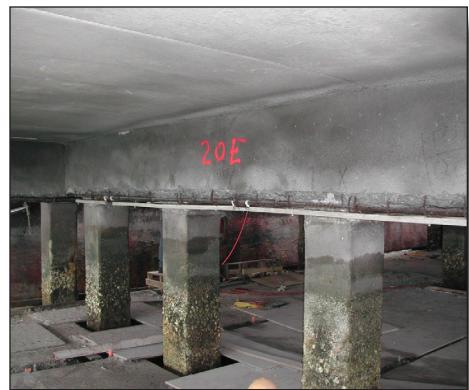
Galvanode DAS on Pile Caps

The cast-in-place pile caps were also showing signs of distress, with the highest exposure to chloride contaminated seawater along the bottom section. A protection system was devised whereby the bottom 8 in. of the pile caps were removed, and activated distributed anode strips (Galvanode DAS) were placed in two continuous rows on each side of the pile caps. Approximately 6,000 lineal feet of pile caps were protected.
