**Vector™**  
**Norcure® Chloride Extraction**  
Project History

**Chloride Extraction Field Trial on  
Burlington Skyway**

- Structure:** West Column, Pier S19,  
Burlington Skyway
- Location:** Burlington, Ontario, Canada
- Client:** Ontario Ministry of Transportation
- Area Treated:** 331.5 ft<sup>2</sup> (30.8m<sup>2</sup>)
- Duration:** 8 weeks
- Contractor:** Concrete Protection Systems

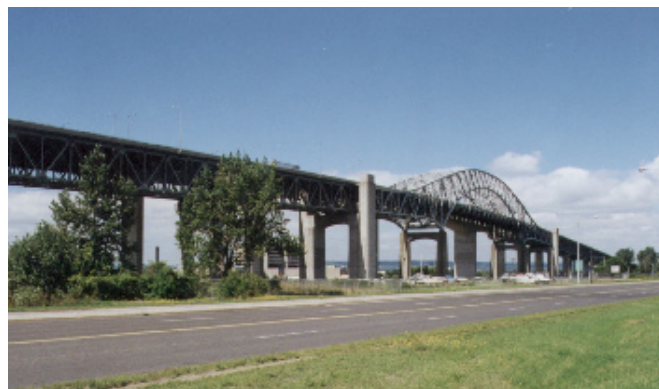
Built in 1955, the Burlington Skyway was designed with less reinforcement than the typical bridge column, which made this site a perfect candidate for the first field trial use of Norcure Electrochemical Chloride Extraction. The system was installed on the lower 13 ft (4 m) of the west column. Only three sides of the square column were treated, leaving the north side to act as a control area. Throughout the duration of the treatment, the system was monitored very closely, often daily, to have sound results throughout testing. After treatment was completed, it was found that the percentage of chloride ions removed above reinforcing steel was as high as 87% in some areas. Corrosion potential results showed that 6 months later, after depolarization, the reinforcement was in a passive and noncorroding state. MTO has continued to monitor the pier since the application of the Norcure System. These long term results show how ECE's effectiveness has withstood the test of time.
