Vector™
Galvashield® XP
Project History

**Colorado Department of Transportation
 Bridge Deck Rehabilitation**

- Structure:** Bridge Deck Route 85 Bypass
- Location:** Greeley, Colorado, USA
- Specifier:** Colorado Department of Transportation
- Contractor:** Randall & Blake

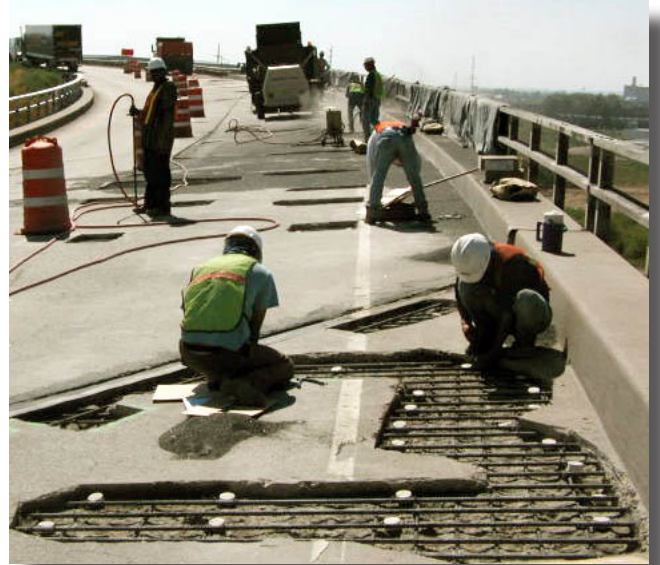
Installing Galvashield XP in bridge deck repairs

Over the course of time, chloride induced corrosion resulted in delaminating and spalling of this heavily traveled bridge deck.

Galvashield XP anodes were used as part of the bridge deck rehabilitation project. The embedded galvanic anodes will provide localized corrosion protection and reduce future maintenance costs.
